Periodic Inspection of Jetties at Manasquan Inlet, New Jersey

Armor Unit Monitoring for Period 1994-1998

*by Robert R. Bottin, Jr., WES
William F. Rothert, Philadelphia District*

Final report

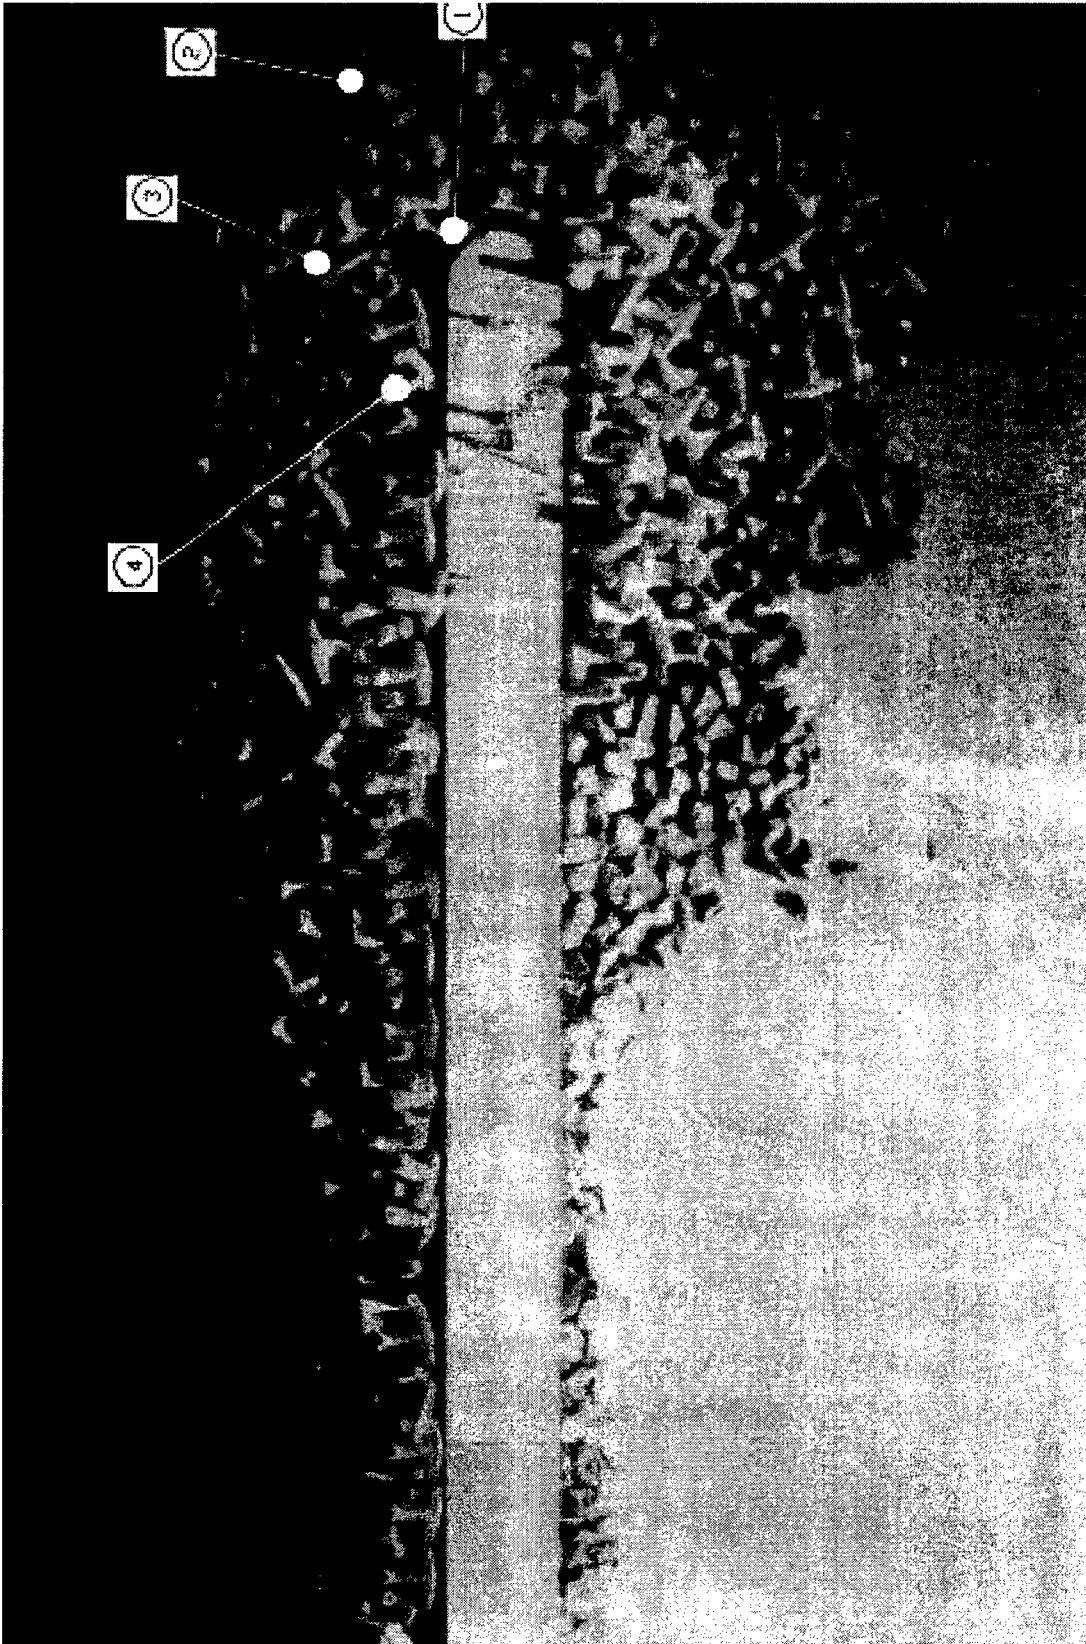
As stated earlier, 17 broken/cracked dolos armor units were identified during the November 1994 survey, mostly around the heads of the jetties. During the October 1997 CORE-LOC jetty rehabilitations, however, several broken dolos were removed from the heads of the structures. As a result, the current (November 1998) survey revealed eight broken/cracked dolos armor units on the Manasquan Inlet jetties. Four units were observed on each jetty, and their

locations are shown in Figures 23 and 24. Some of the data recorded relative to these broken/cracked dolos armor units are shown in Table 4. Of the eight broken/cracked dolos armor units observed, six were identified in the previous (1994) survey, and two (units 1 and 4 on the north jetty) were new breaks.

Figure 24. Approximate locations of broken/cracked dolos armor units on south jetty

Table 4 Broken Armor Unit Survey			
Unit No.	Offset from Jetty Cap, m (ft)	Type of Break	Comments
North Jetty			
1	3.1 (10)	Angled fluke-shank	Fluke chipped
2	5.2 (17)	Angled shank-fluke	Hairline crack
3	1.5 (5)	Straight shank-fluke	Hairline crack, fluke chipped underneath
4	7.9 (26)	Angled midshank	Rebar exposed
South Jetty			
1	1.1 (3.5)	Straight shank-fluke	Cracked through
2	11.4 (38)	Straight shank-fluke	Fluke broke off
3	10.1 (33)	Straight shank-fluke	Fluke only
4	1.5 (5)	Angled shank-fluke	Cracked through

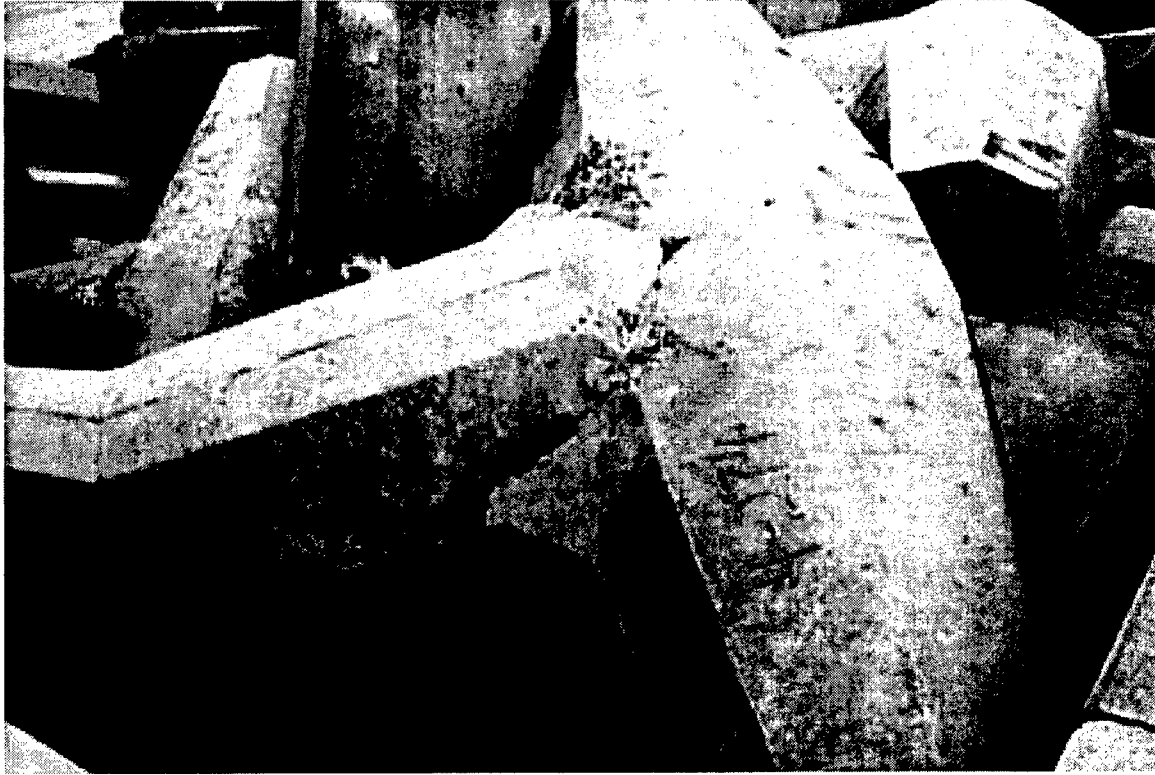
Considering the types of breaks, the majority (six) were shank-fluke breaks. There was one midshank break and one fluke-shank break. There were four angled breaks and four straight ones. Comparison of breakage to production data showed that no production group had an unusual amount of breakage. The distribution of broken/cracked dolosse indicated that seven of the eight units were concentrated around the seaward heads of the jetties, as shown in Figures 23 and 24. Views of typical broken/cracked dolos armor units on the Manasquan Inlet

- (a) stress patterns within the original cast dolosse, (b) handling and placement, (c) settling of the structure, stressing units within the breakwater, (d) wave-induced displacement, (e) wave-induced rocking and fatigue failure, (f) ice pressure and movement, and (g) impact from debris, other dolosse, and dolos fragments.

Figure 26. Dolos with angled shank-fluke break

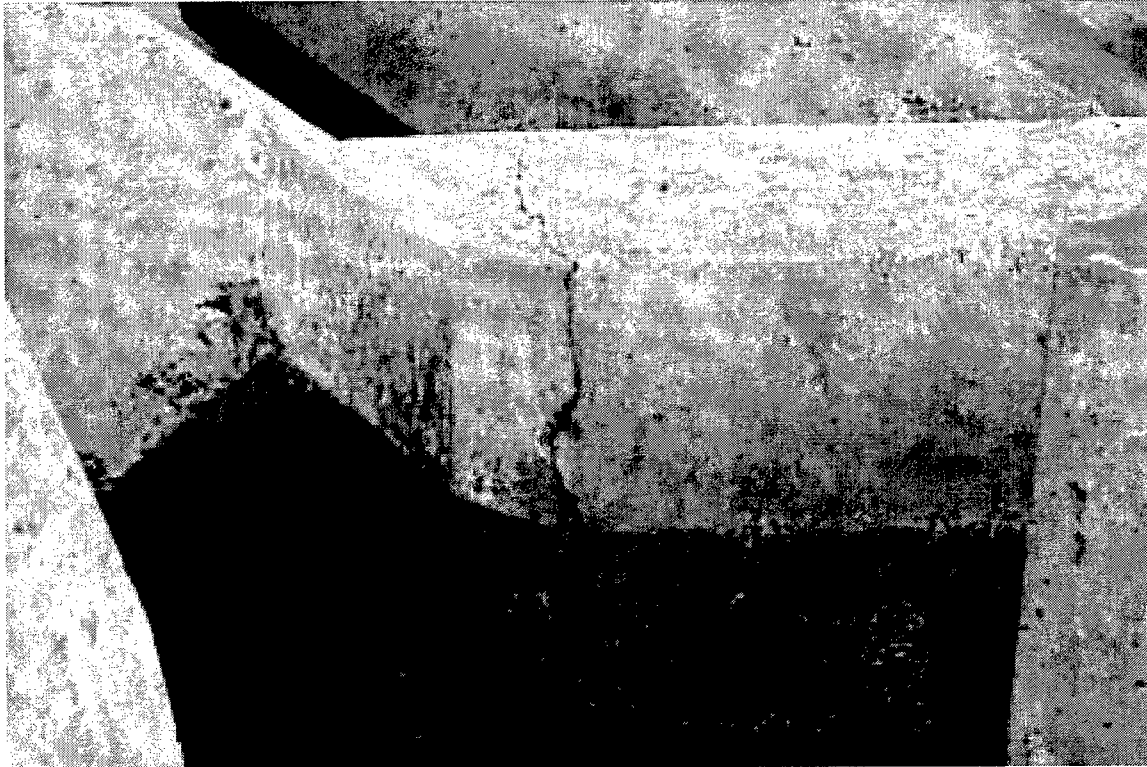
Figure 27. Dolos with straight shank-fluke crack
